Digging for Britons! High Carlingill, Cumbria

2018 Community Archaeology Excavation Interim Report

| Project Reference: | SOL1718-93 |

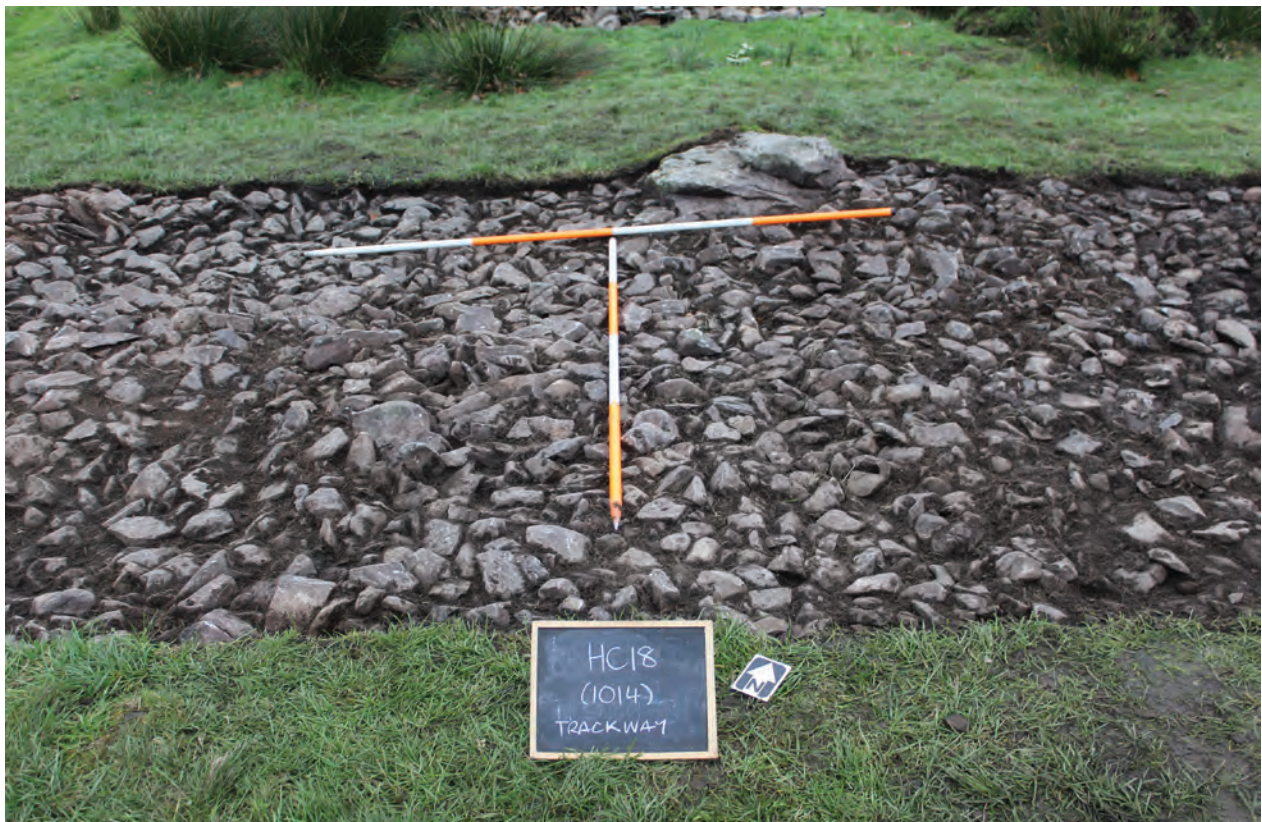
Figure 7 Later trackway which cut through the sub-circular enclosure bank, facing north-west. Scale 2 x 2 m

The stratigraphically latest feature observed across the site was a metalled trackway aligned north-west to south-east which roughly followed the contour of the hillside and measured c. 4 m wide. The trackway was constructed of rough stone surface of sub-angular stones (1014) which measured c. 0.15 m thick and were compacted and embedded into a dark grey-black, silty clay soil (1022) measuring approximately 0.10 m in thickness. The stone surface and soil foundation directly overlay the cut [1023] through a large, earlier enclosure bank (1003/1009/1024) (see below), which left two raised remnants either side of the track (1003/1009 and 1018). The track respected the alignment of the later, sub-rectilinear enclosure (1008) (see below), alongside which it ran. A sondage was cut through the track to investigate the composition of the foundation and to confirm the relationship between the track and the enclosure bank. It was determined that the track foundation (1022) and surface (1014) lipped up against the bank remnant (1018) where it had been cut away [1023] to facilitate the track's construction. The track appeared to truncate the cobbled surface at the doorway of Structure 1 (see below). The relationship with the stone tumble (1002) which had cascaded down the slope (1008) of the later sub-rectilinear enclosure was uncertain.

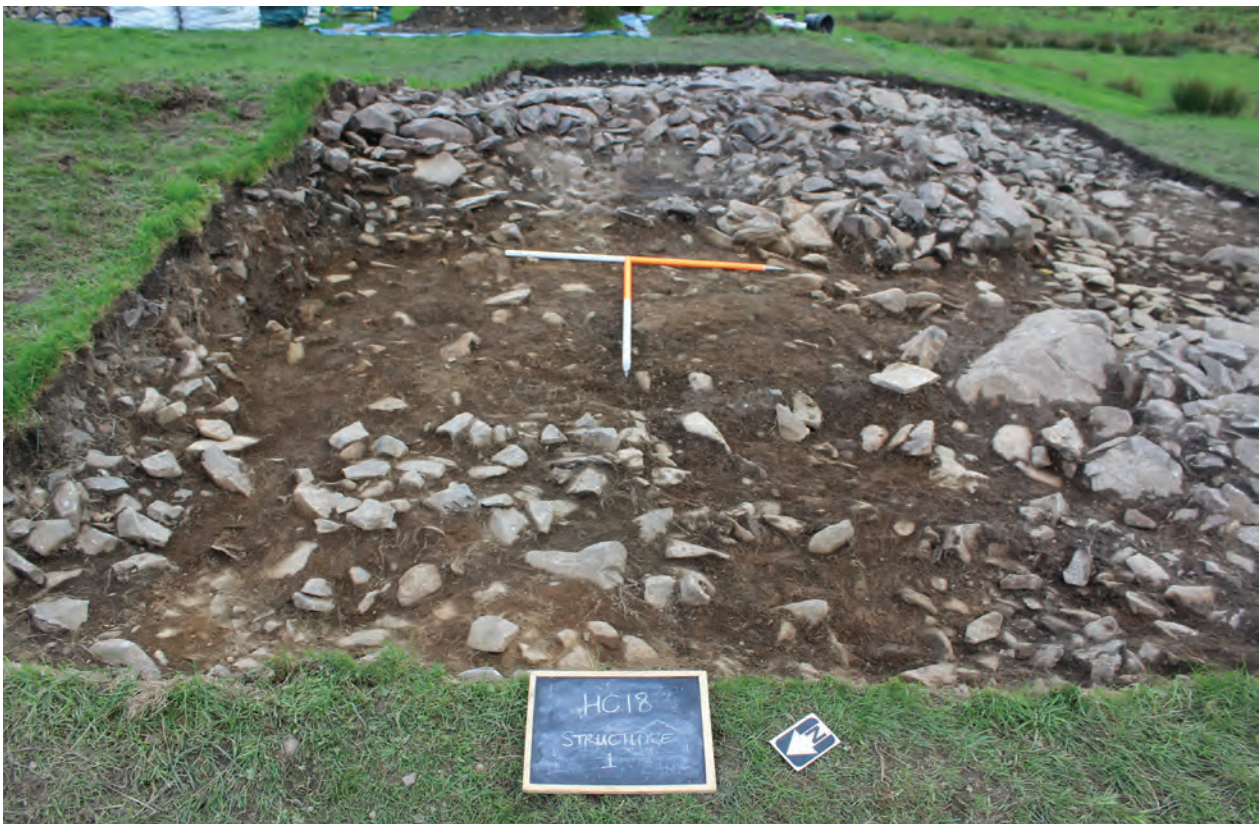
Figure 9 Structure 1, facing south-east. Scale 2 x 1 m

The circular footprint for the structure was cut [1026] through the enclosure bank and appeared to use part of the remaining bank to the east to support its wall on this side. The cut was not sufficiently observable to describe it in any detail, but it unequivocally truncated the earlier enclosure bank. Wall (1017), which defined the circumference of the structure, was constructed of small sub-angular stones pitched and packed together within a dark brown, clayish soil matrix. The wall was rudimentary in build, being of poor quality and form, and survived as a rough foundation course which measured c. 0.5 m in width. A doorway to the interior of the structure was observed facing south-west. The doorway measured approximately 0.8 m in width and was defined by large stones set either side. The stone to the south-east formed part of a level terrace upon which Structure 1 was partially built (see below). The stone to the north-west was probably part of the earlier enclosure bank face (1009) which had been laid perpendicular across the bank to form a solid foundation for wall (1017). The wall was almost entirely absent along its northern circumference, although this may have been the result of possible quarrying for stone during the recent past. It is probable that the wall of Structure 1 was constructed using the enclosure bank stone through which it cut.

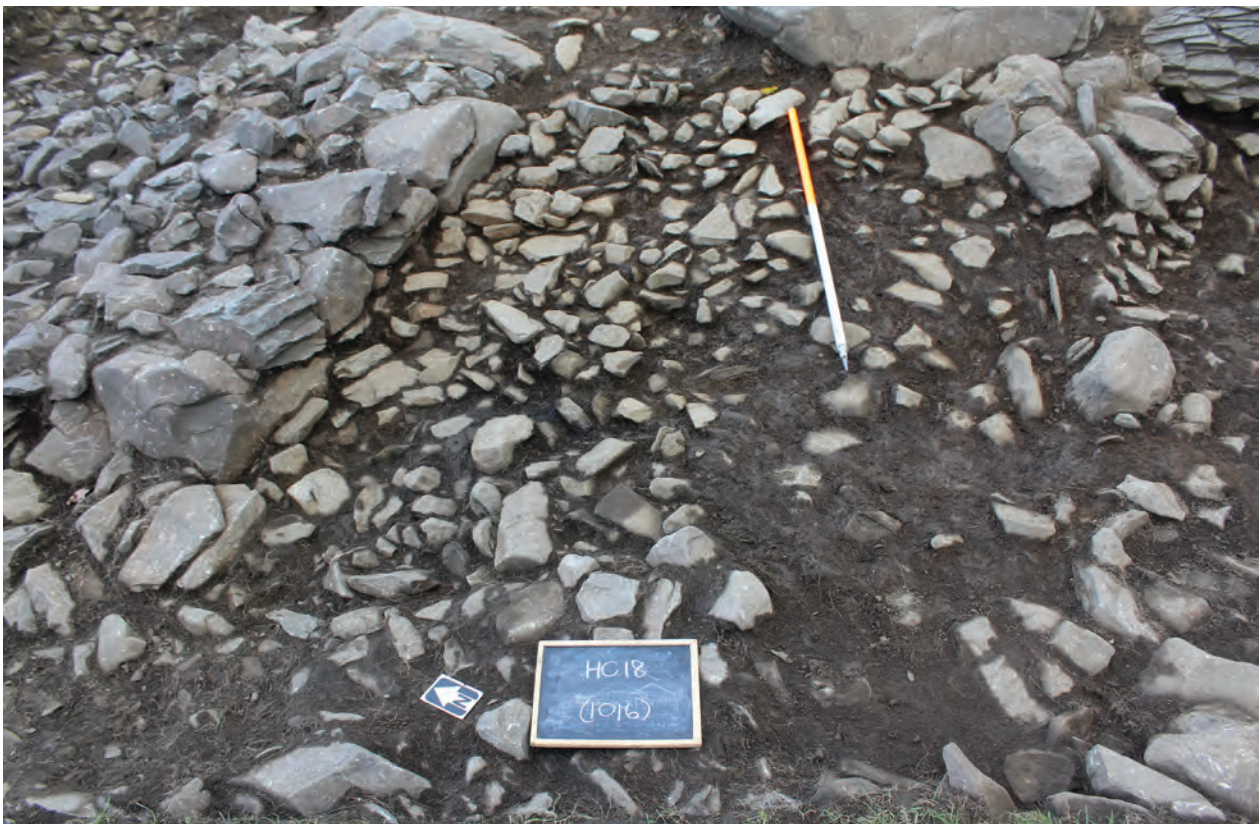
Figure 11 Cobbled surface leading to the entrance of Structure 1, facing north-east. Scale 1 x 1 m

A well-constructed cobbled/stone surface (1016) was observed in front of Structure 1 leading out of the doorway. A fragment of South-East Dorset Black Burnished 1 ware dating to the 2nd century AD was recovered from this context. The surface respected the entrance of the doorway and did not travel into the interior of the structure, and therefore the relationship between (1016) and floor surface (1005) remained uncertain. The surface (1016) was composed of sub-angular and angular stones of various sizes packed into a dark-grey silt clay soil matrix and was observed for a distance of c. 2 m to the west. The metallised surface abutted facing stones (1009) of the earlier enclosure bank and were cut during the construction of the later trackway (1014). The relationship between (1016) and a probable early stone surface (1004), which was situated to the south-east, was indeterminate.

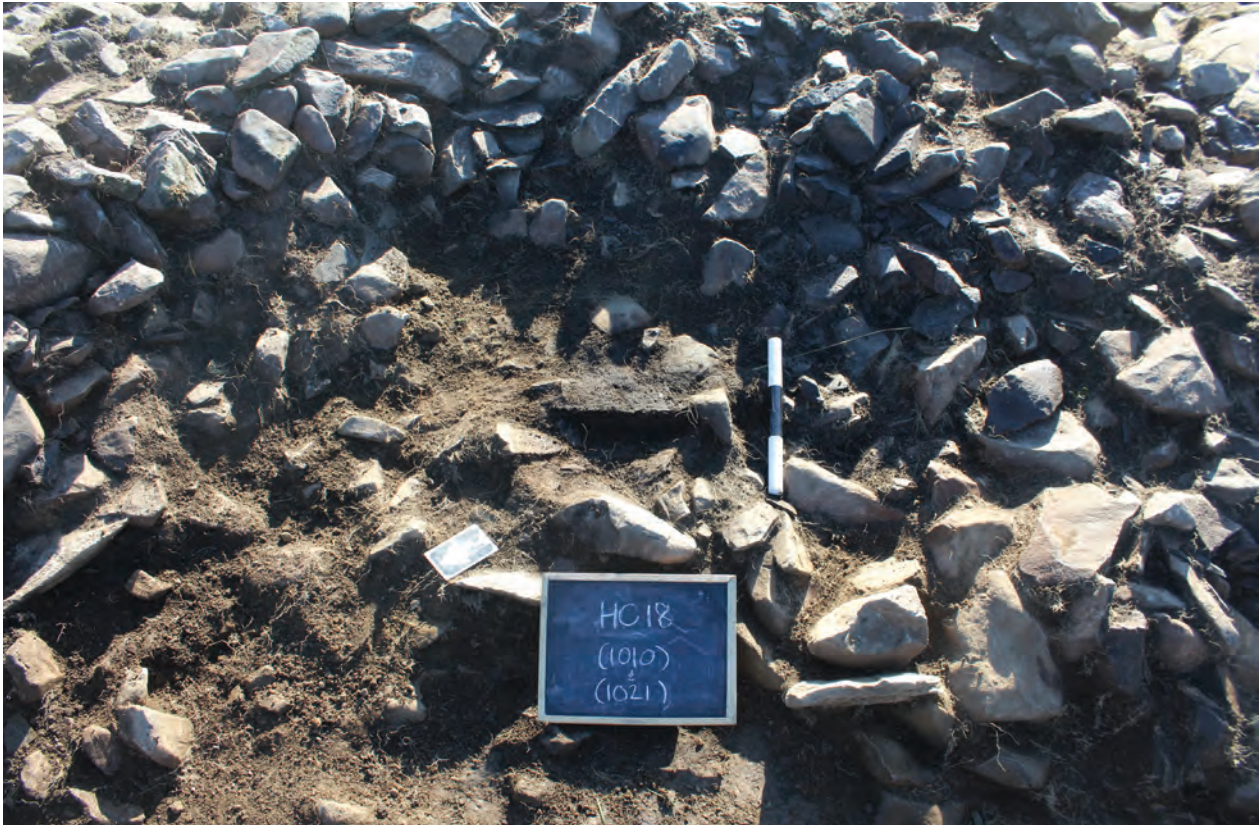
Figure 12 Structure 1 possible hearth (1010, 1021, 1028), facing south-west. Scale 1 x 0.3 m

The low stone platform (1028) measured no greater than 0.25 m in height and was constructed of poorly arranged sub-angular stones packed within a mid-red-brown clayish silt soil matrix, set against the southern circumference of wall (1017). The platform was of a greater thickness downslope (to the south-west) and was therefore interpreted as having been constructed to provide a level and raised surface upon which to contain the possible hearth (1021/1010). The platform overlaid a compacted deposit (1019) of dark brown silty clay with sub-angular stone inclusions. It was uncertain whether this earlier deposit represented a foundation for the degraded floor (1005) or was an earlier floor surface that had been repaired. The surface was uneven and gradually sloped down to the north-west where it met the fragmentary remnant of wall (1017). The uneven nature of this deposit and fragmentary/degraded appearance of the floor surface (1005) may suggest that (1005) was

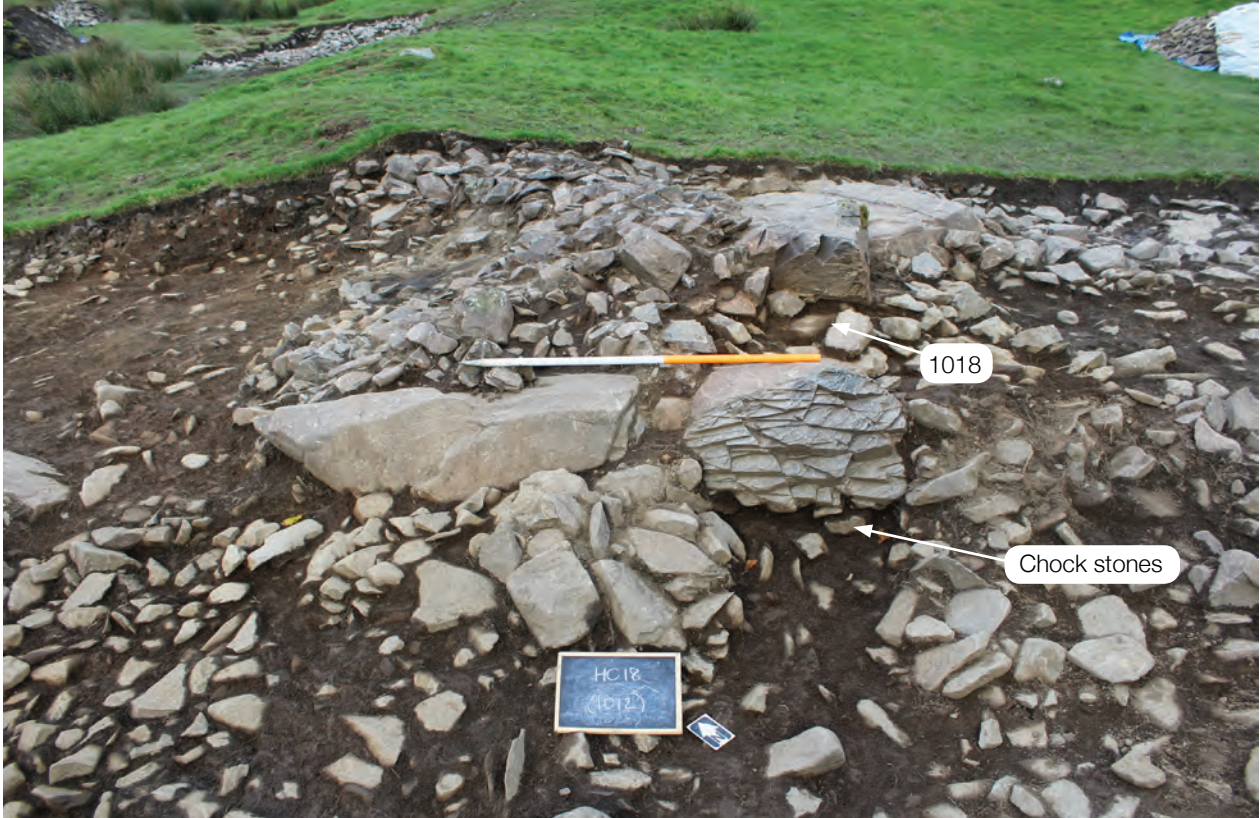
Figure 14 Foundation stones (1012) with core infill (1018) and chock-stones highlighted, facing north-east. Scale 1 x 1 m

Immediately beneath the southern circumference of wall (1017) of Structure 1 was a foundation feature constructed of large oblong stones (1012) arranged to form a 90° corner. At least three large stones, the largest of which measured c. 1.3 m x 0.4 m x 0.3 m, were observed. The stones (which were not removed due to their weight) were embedded directly into the natural slope of the hillside and were probably re-used from the dismantled earlier enclosure bank (1003/1009). Small chock-stones were noted packed beneath the fractured corner stone of the retaining structure, which led to the interpretation that the hill slope had not been cut to accommodate them, rather they were placed on the slope and supported from slipping.

A core deposit of soil and smaller packing stones (1018) was observed behind and over stones (1012) creating a level platform on the slope of the hillside. Deposit (1018) was composed of a dark reddish-brown clayish silt with frequent small stone inclusions and was overlain by wall (1017) of Structure 1.

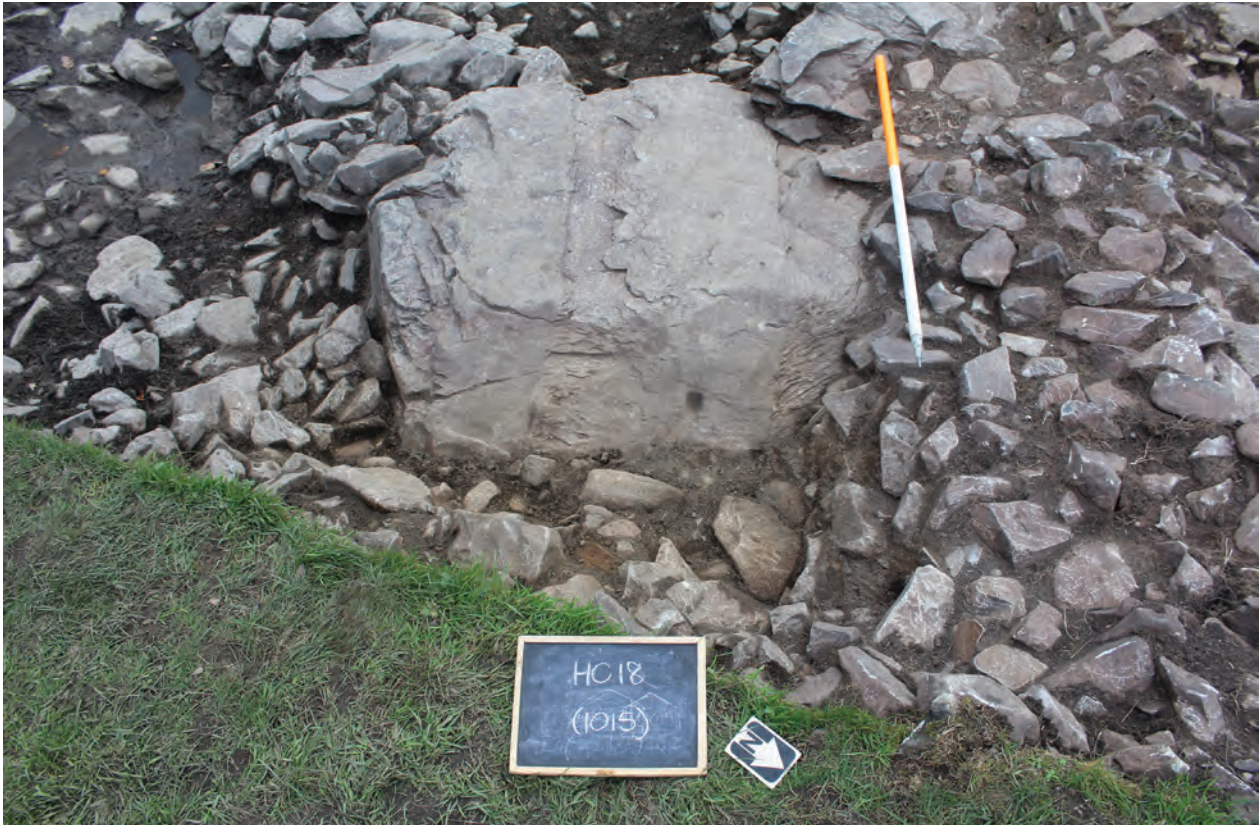
Figure 15 Worked stone (1015), facing south-west. The two parallel channels are clearly visible. Scale 1 x 1 m

Foundation structure (1012) was partially laid onto a large (and presumably in situ) stone (1015) which was observed to its east. The stone measured approximately 1 m by 1 m, although its thickness remains unknown as it was not fully excavated. The upper surface, north-east and south-west faces had been pecked or chiselled. This resulted in two parallel grooves, or channels, aligned north-east to south-west across the stone. The cutting of the southernmost channel appeared to have utilised a natural fracture in the rock which was augmented to create the channel. The northernmost channel was partially overlain by the wall (1017) of Structure 1. A small, worked, sub-circular depression was noted between the two channels. The original purpose of these channels and the

sub-circular depression remains unclear. However, a gully (1013) (see below) extended from the southernmost channel downslope and cut across the rectilinear enclosure bank (1008). Based on their spatial relationship, the channel was interpreted as having been used to direct water away from Structure 1 — a drip gully of sorts.

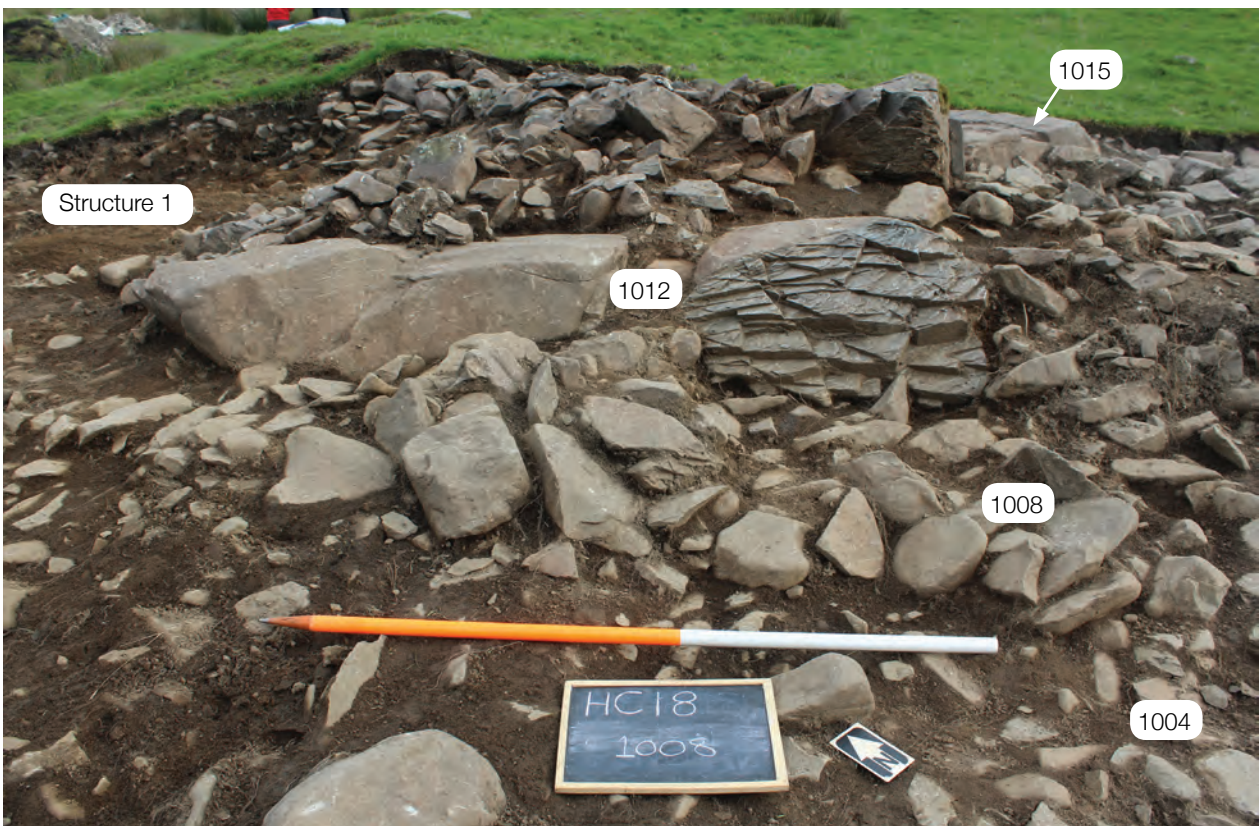
Figure 16 The tapering edge of the sub-rectilinear enclosure bank (1008), abutting (1012) and overlaying surface (1004), facing north-east. Scale 1 x 1 m

Abutting and partially overlaying both the worked stone (1015) and foundation stones (1012) was a sub-rectilinear enclosure bank (1008). The bank extended from the stone foundation towards the south. The tapering edge of the bank was observed abutting the foundation stones (1012) and terminating before it reached the entrance to Structure 1, suggesting that the use of the structure and later enclosure may have been contemporary. The bank was formed of a rooted spread of irregular, angular stones of various sizes (1002) poorly arranged across the slope of the bank. A locally made everted cooking pot rim dating to the 2nd century AD was recovered from this context. (1002) immediately overlay a fairly regular spread of stone (1008) which was packed into the slope of the bank. Deposit (1008) was not removed, and therefore the complete composition of the bank was not investigated. The bank (1008) overlay an earlier surface (1004) (see below). The enclosure bank continued south beyond the limit of excavation. A number of sherds of Samian ware and South-East Dorset Black Burnished 1 ware pottery, dating to the 2nd century AD, were recovered from this context. In addition, radiocarbon determination of willow/poplar (*Salicaceae*) charcoal from the bank make-up returned a date range of 340–50 cal BC (95.4% probability) but with a tighter 1 σ (68.2% probability) of 190–100 cal BC.

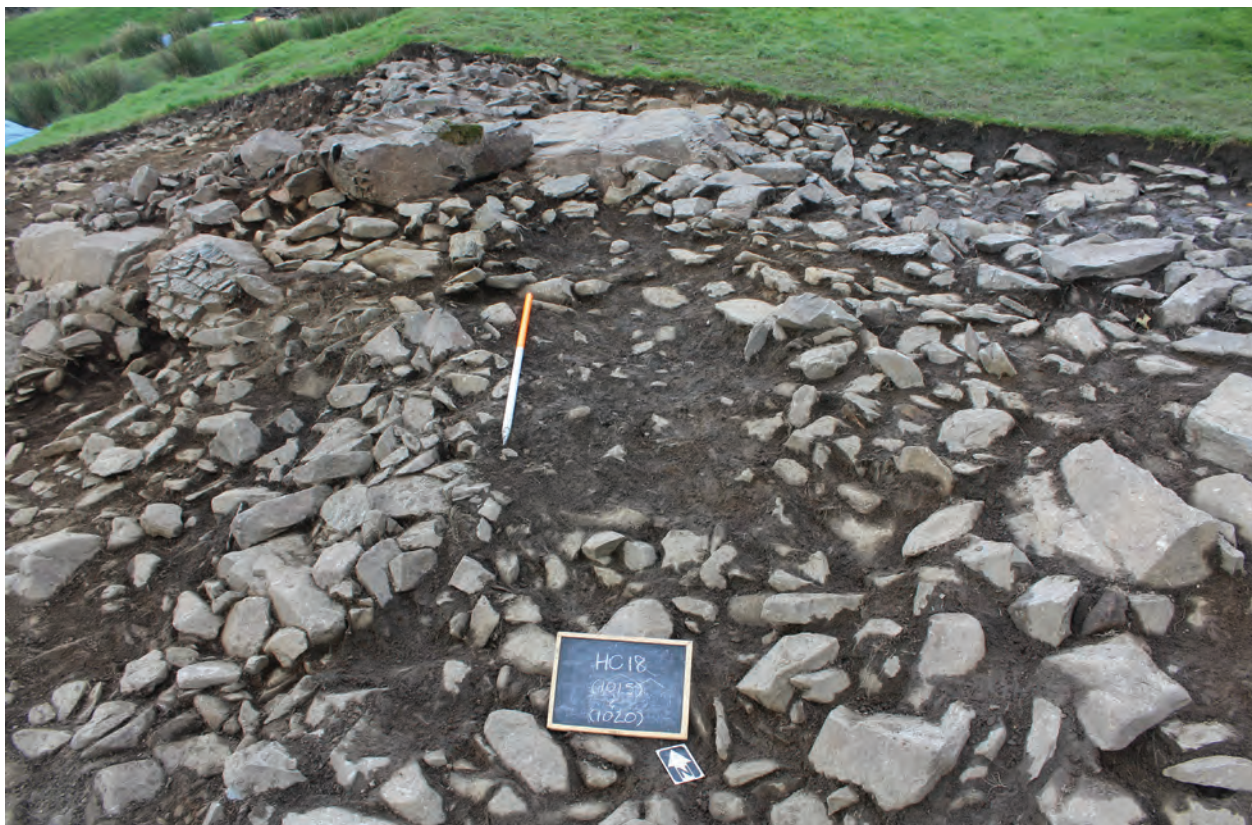
Figure 19 Gully (1013/1020) cutting across the rectilinear enclosure bank (1008), facing north-east. Scale 1 x 1 m

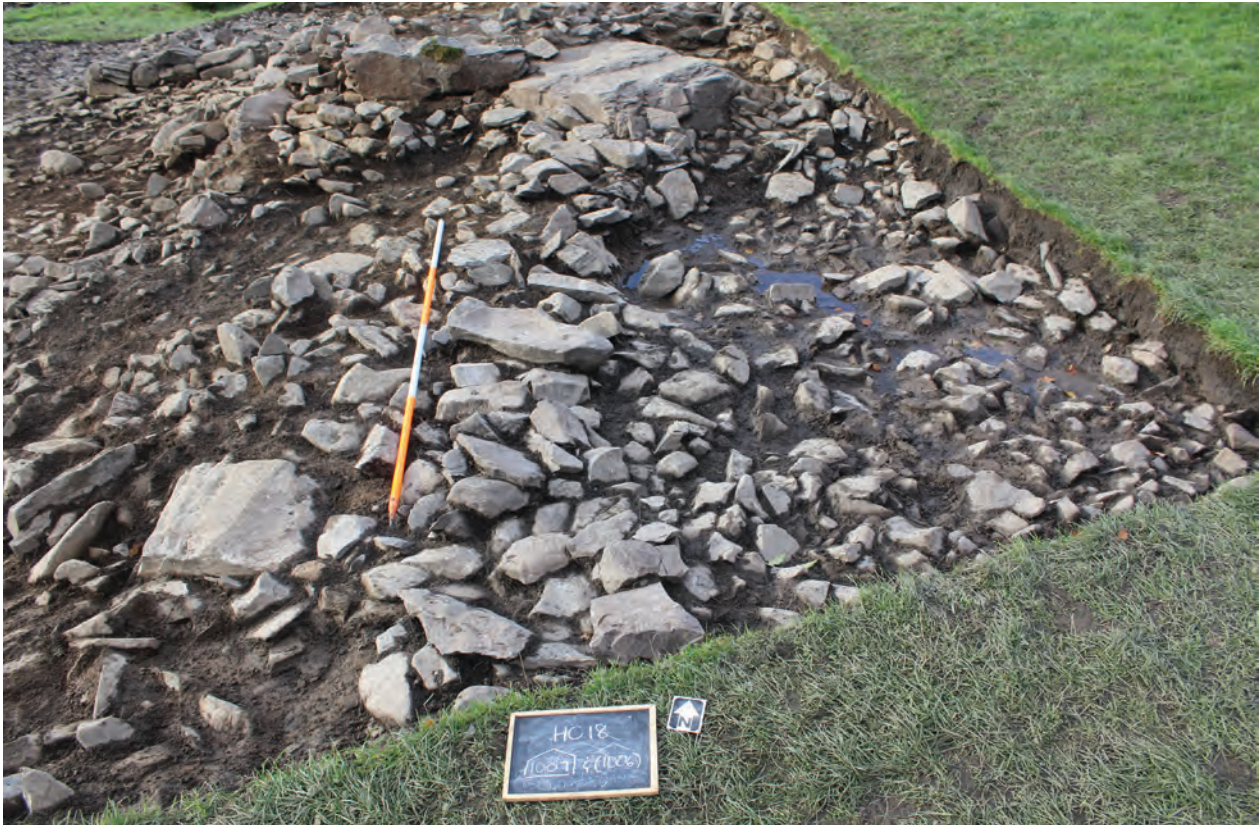
Figure 20 Wall (1007) at the break of slope of the sub-rectilinear enclosure bank (1008), facing north. Scale 1 x 2 m

The foundation courses of a rough built wall (1007) were observed overlying bank (1008). The wall was constructed of angular and sub-angular stones of various sizes, roughly laid at the break of slope of the enclosure bank (1008) in a curvilinear alignment, roughly orientated north to south. Two courses of foundation masonry were observed, but no bonding material was present. Flatter faced stones were generally laid to either side, with coarse, angular stones pitched in between. The wall, which measured approximately 0.6 m wide, abutted and partially overlay the large worked stone (1015) but did not have a discernible relationship with Structure 1 beyond.

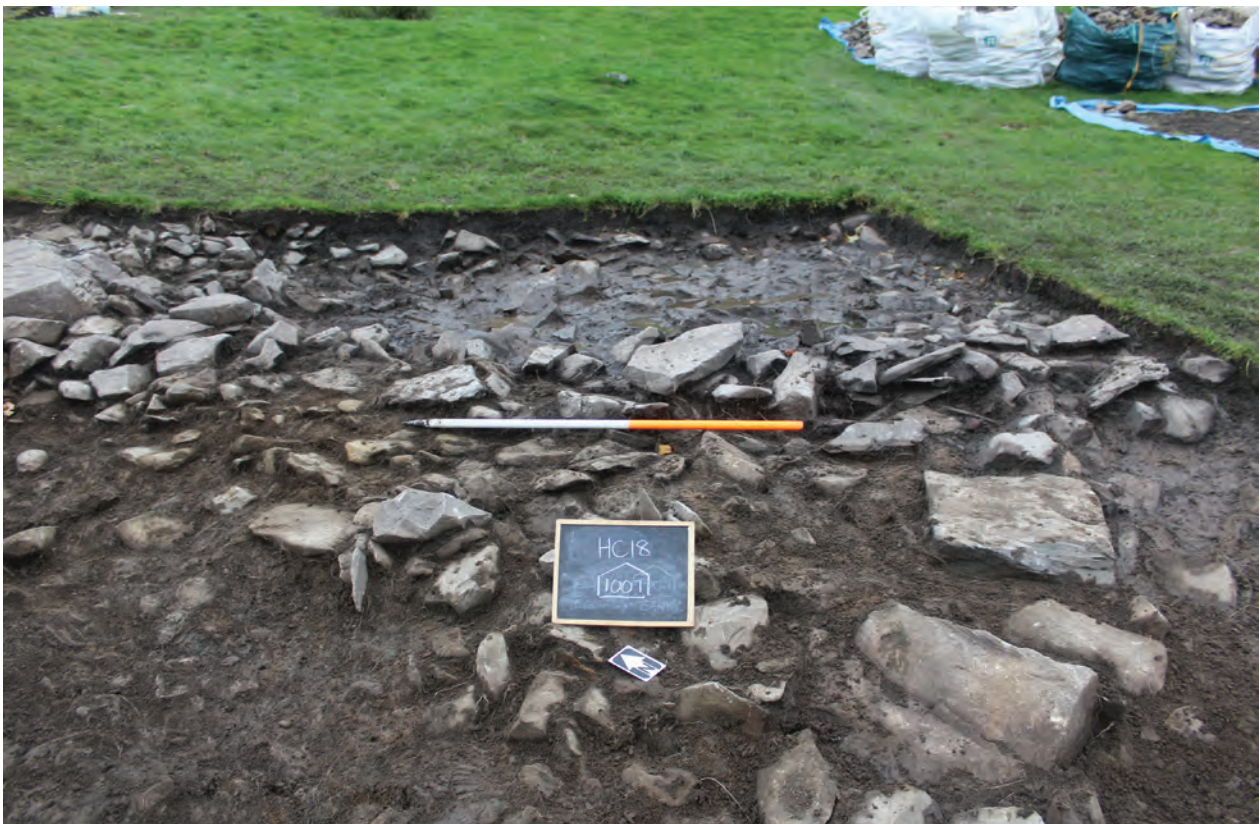
Figure 21 Wall (1007) and yard surface (1006) beyond it, facing north. Scale 1 x 1 m

Immediately abutting wall (1007) to the east was a yard surface (1006). The yard was constructed of irregular sub-angular and angular stones of various sizes, packed into the upper surface of the bank. The surface was degraded and in poor repair. Directly above the yard surface (1006) was a discrete spread of firm, dark grey clayish silt, measuring c. 0.06 m in thickness, that was interpreted as probable colluvial infill which had gathered in the rough and degraded areas of the yard. A better laid area of yard surface was noted towards the southern limit of excavation. This comprised smaller sub-angular stones which were tightly packed into the bank soil and formed a less rough and degraded surface. The extent of this area measured approximately 0.5 m wide and appeared to continue beyond the limit of excavation.

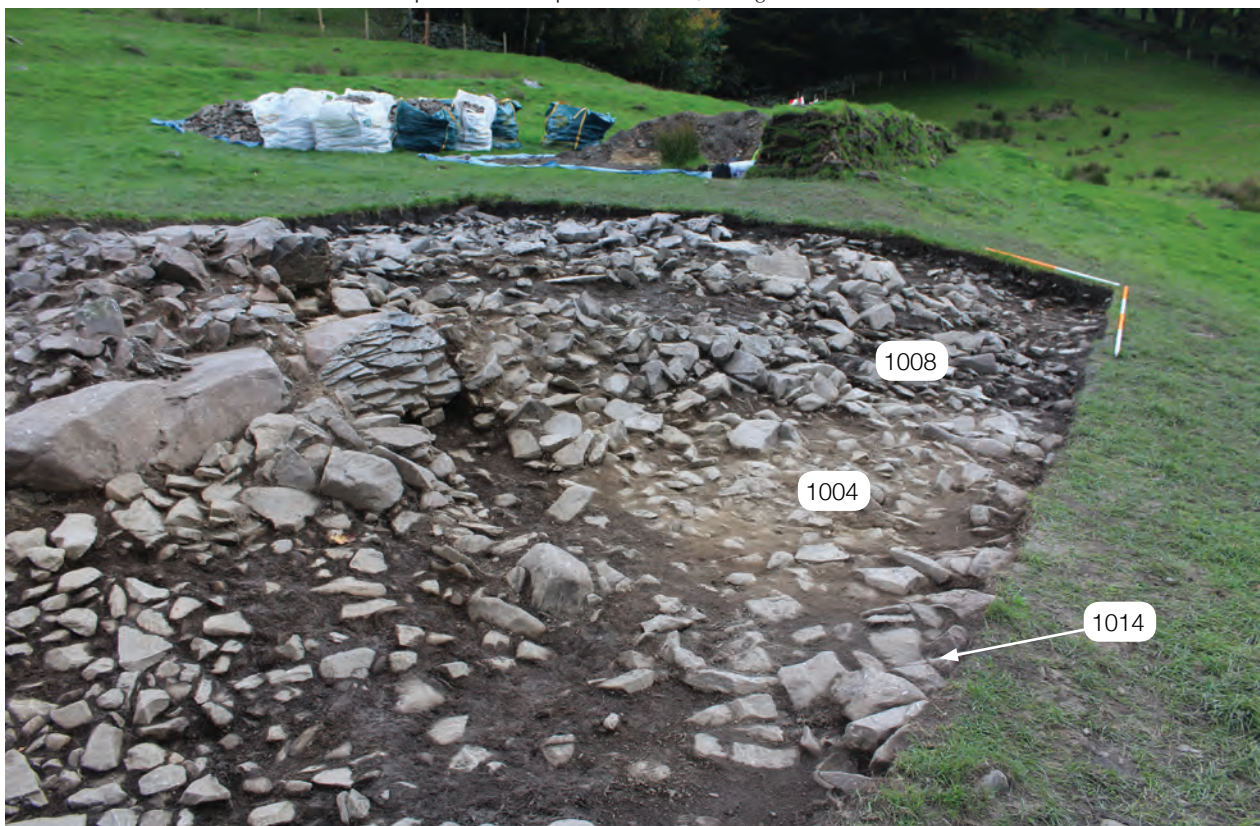
Figure 23 Possible earlier surface (1004) overlain by the sub-rectilinear enclosure (1008) and the later trackway (1014), facing south-east. Scale 1 x 1 m and 1 x 2 m

Overlain by the sub-rectilinear enclosure bank (1008) was a compact stone surface (1004). This surface comprised irregularly laid stone packed into a clayish soil (probably the natural hillside) to make a flat surface. The surface, which generally sloped down with the gradient of the hill, appeared to continue beneath the foundation stones (1012), but this relationship was uncertain. If (1004) was overlain by (1012) then it represents a surface that was in place prior to the installation of Structure 1 and the sub-rectilinear enclosure. A number of sherds of locally made wares, dating to around the 2nd century AD, were recovered from this context.

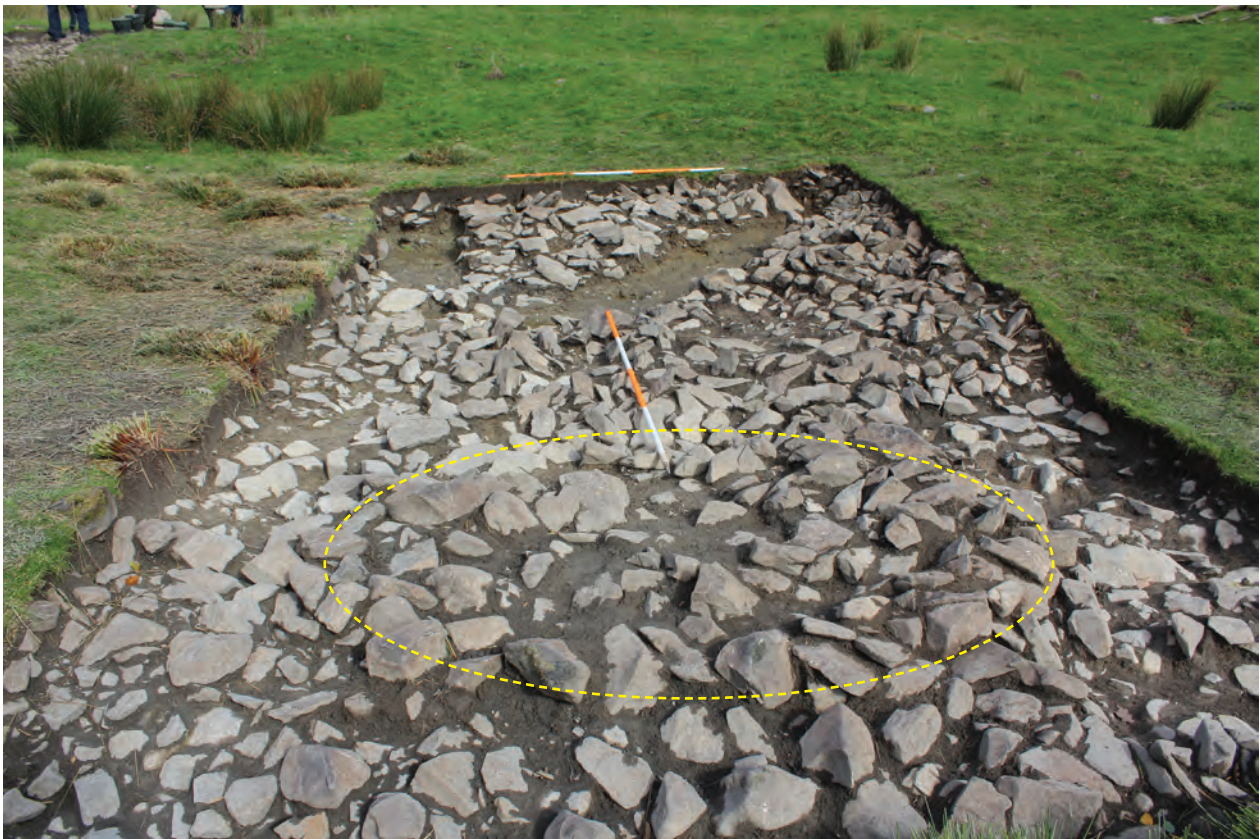
Figure 29 Structure 5 is indicated by the dashed yellow line, facing east. Scale 2 m

Structure 5 comprised a sub-circular, raised, pitched stone foundation (2011), measuring c. 2.70 m in diameter, set within a dark brown silty soil matrix. On average, the stones measured c. 160 x 200 x 40 mm in size and were haphazardly packed together. A broken stone quern base had been re-used in the construction of the foundation, which was rudimentary in appearance. A presumed cut was recorded, but not observed, for the construction of the structure.

The pitched stones (2011) overlaid a rough and fragmentary surface (2019), composed of flat stones embedded into a compact grey-green clay (2020) which appeared to form the core of the terrace platform (2013). The sub-angular flat stones measured on average c. 250 x 200 x 40 mm in size and were poorly arranged. This rough stone surface was interpreted as relating to the earlier phase of use of the area, when Structures 3 and 4 were active, and probably represented a yard surface or similar between the two structures. An alternative consideration was that the stone surface represented a repair to the platform terrace (2013) (see below).

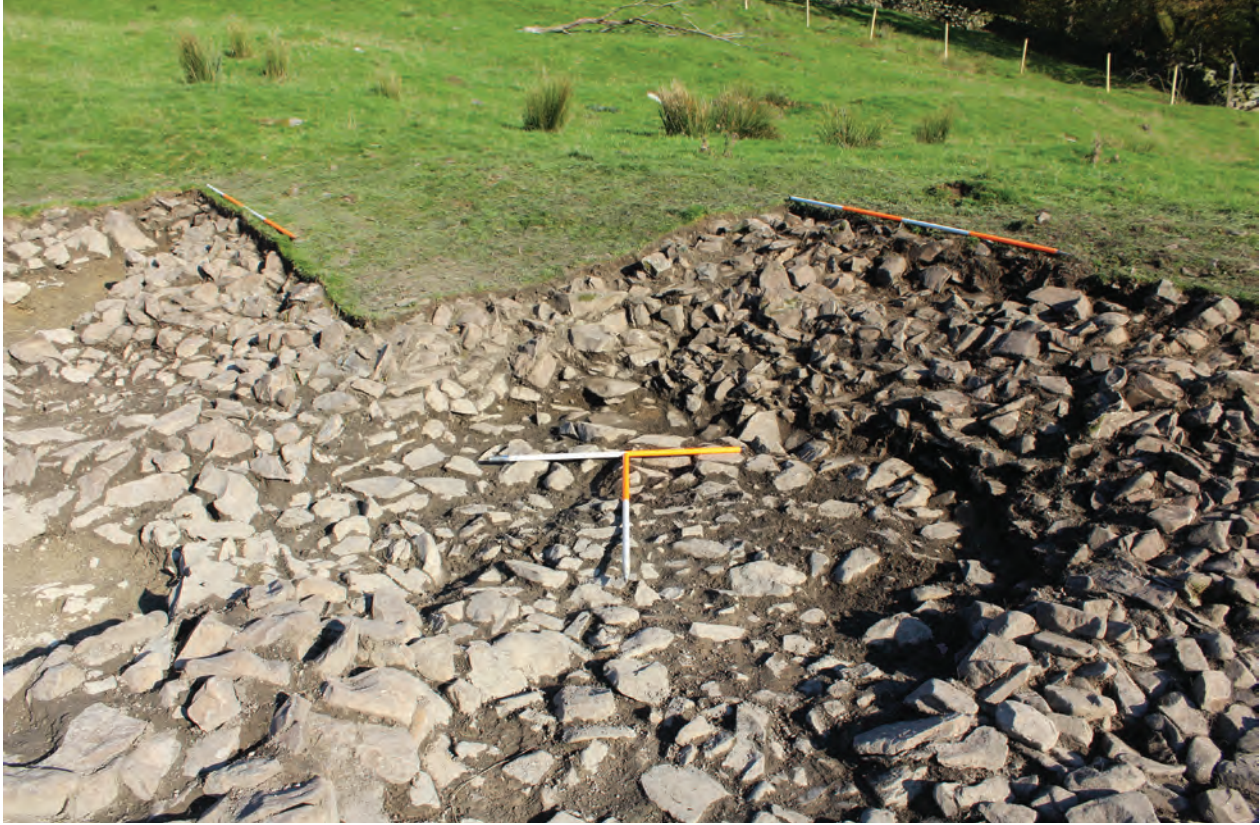
Figure 30 Sub-circular Structure 3, facing east. Scale 2 x 1 m

A small, stone-built, sub-circular structure (Structure 3) was observed towards the southern extent of the trench, overlain by colluvial deposit (2001) and stone tumble (2002), but stratigraphically beneath the cut [2012] of Structure 5. The feature generally measured c. 2.90 m across, with an internal space of c. 2.5 m.

Abutting the interior face of wall (2003) was a well-constructed floor surface (2004) which comprised horizontally laid flat stone slabs measuring on average c. 200 x 300 x 40 mm. The stones were regularly placed, although there were many areas where stones were missing, presumed robbed. The floor did survive well in an area to the rear (east) of the structure and it was possible to determine that the stones were reasonably well fitted against each other. Immediately beneath the upper surface of the floor was a sub-floor foundation deposit (2005) of pitched sub-angular stones measuring on average c. 270 x 130 x 70 mm which were irregularly placed. Some flatter stones interspersed the pitched stones, and this formed the foundation onto which the upper floor surface (2004) was laid. The sub-floor foundation stones were surrounded by a firm compact grey-green clay matrix which added stability to the foundation.

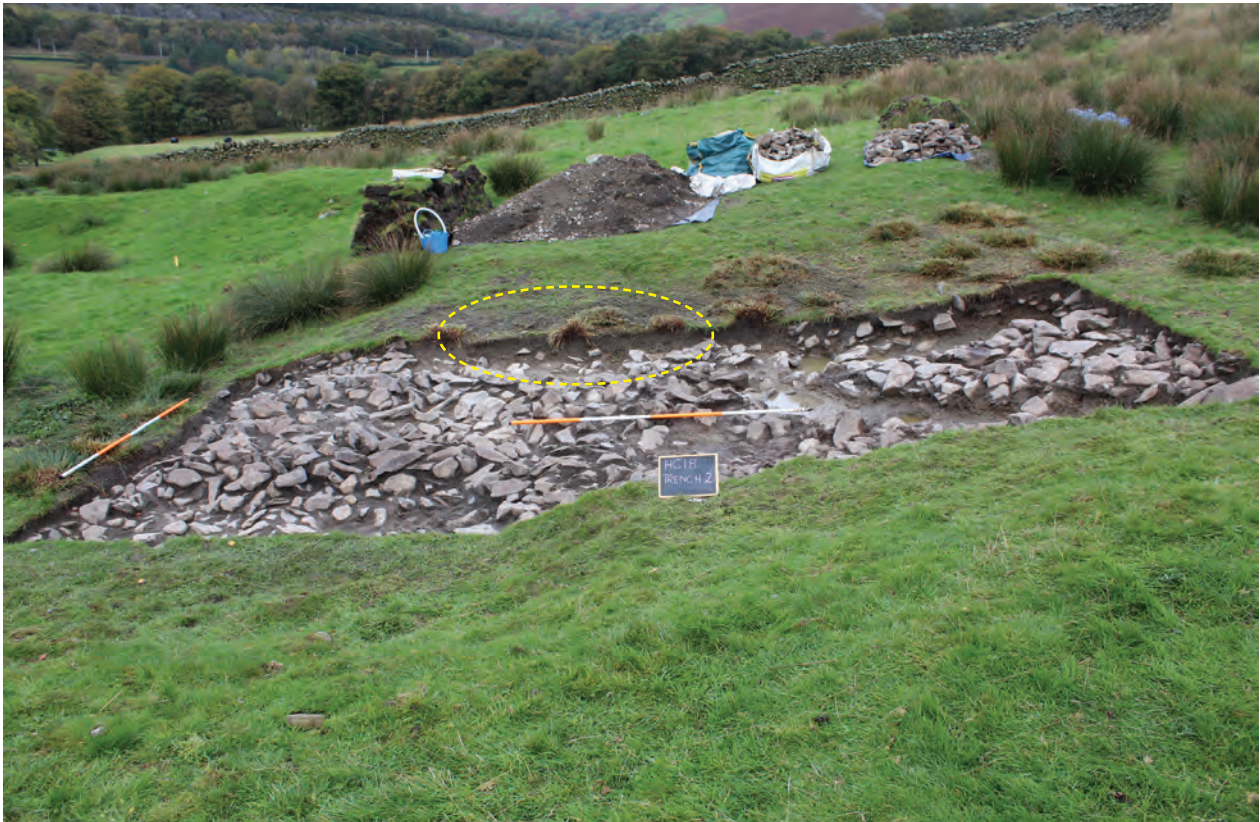
Figure 31 The wall (2009) of Structure 4 is indicated by the dashed yellow line, facing north-west. Scale 2 x 2 m

A sub-circular wall (2009) measured c. 0.45 m in width with an extant height of c. 0.18 m. The wall was constructed of poorly stacked sub-angular stones without bonding, measuring c. 220 x 125 x 80 mm on average, which survived as an irregular and truncated stone footing. The rough stone wall was very fragmentary and disrupted. It was also heavily truncated along its southern edge by Structure 5 (see below). The wall of Structure 4 was not removed and therefore no construction cut was observed or determined. Unlike Structure 3 however, Structure 4 was completely situated on the level platform of terrace (2013) (see below), rather than partially set into the slope of the enclosure bank (2007). It is therefore possible that a construction cut for the external wall was not required, and the stone footing for the wall was laid directly onto the upper surface of terrace (2013). No doorway was observed in the excavated circumference of the wall. Assuming the form of this structure was the same or similar to Structure 3, then the doorway would presumably have faced north-west and would have been located beyond the limit of excavation.

Abutting the interior face of wall (2009) was a fragmentary floor surface (2010) which comprised sub-angular stone slabs, measuring on average c. 300 x 200 x 50 mm, in a compact, mid-brown, silty soil matrix. The floor was very degraded and the surface uneven. It was impossible to determine the construction of this floor and whether it shared similarities with Structure 3.

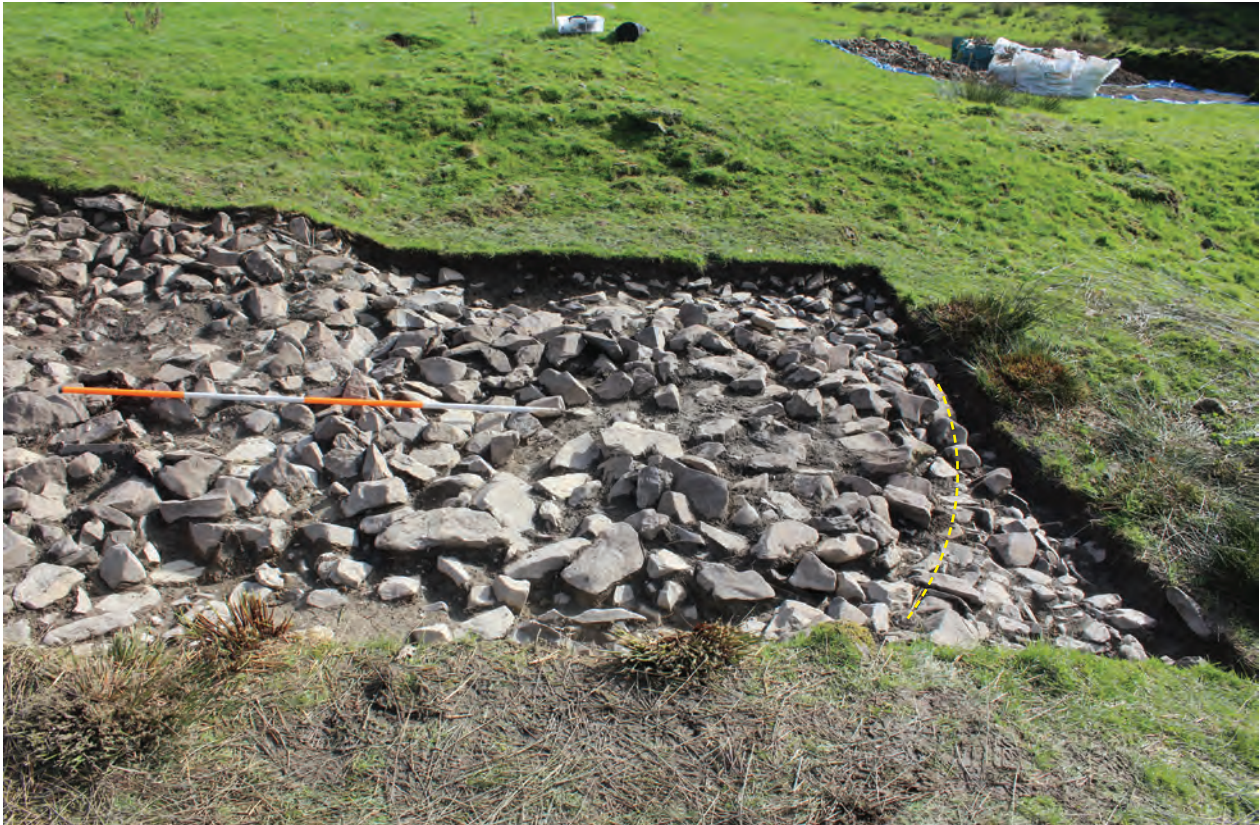
Figure 32 The edge of the terrace (2013) is indicated by the dashed yellow line, facing south-east. Scale 2 m

A level platform or terrace (2013) had been created over the slope of the hillside against the bank (2007). The terrace appeared to have been constructed by depositing a compact grey-green clay (2020), forming the core of the platform which overlaid the lower extents of the enclosure bank (2007), to create a level surface against the slope of the hillside — probably to enable the installation of Structures 3 and 4. Revetment stones (2013) were observed at the front of, and partially overlaying, the terrace. These roughly laid stones were interpreted as providing support to stop the terrace slipping down the natural slope of the hillside. The sub-angular stones, which were an assortment of sizes, were packed against and over the clay (2020) core of the platform and graded down the naturally sloping ground to the west. The front edge of the terrace appears to generally respect the alignment of Structures 3 and 4, thereby suggesting its relationship to them.

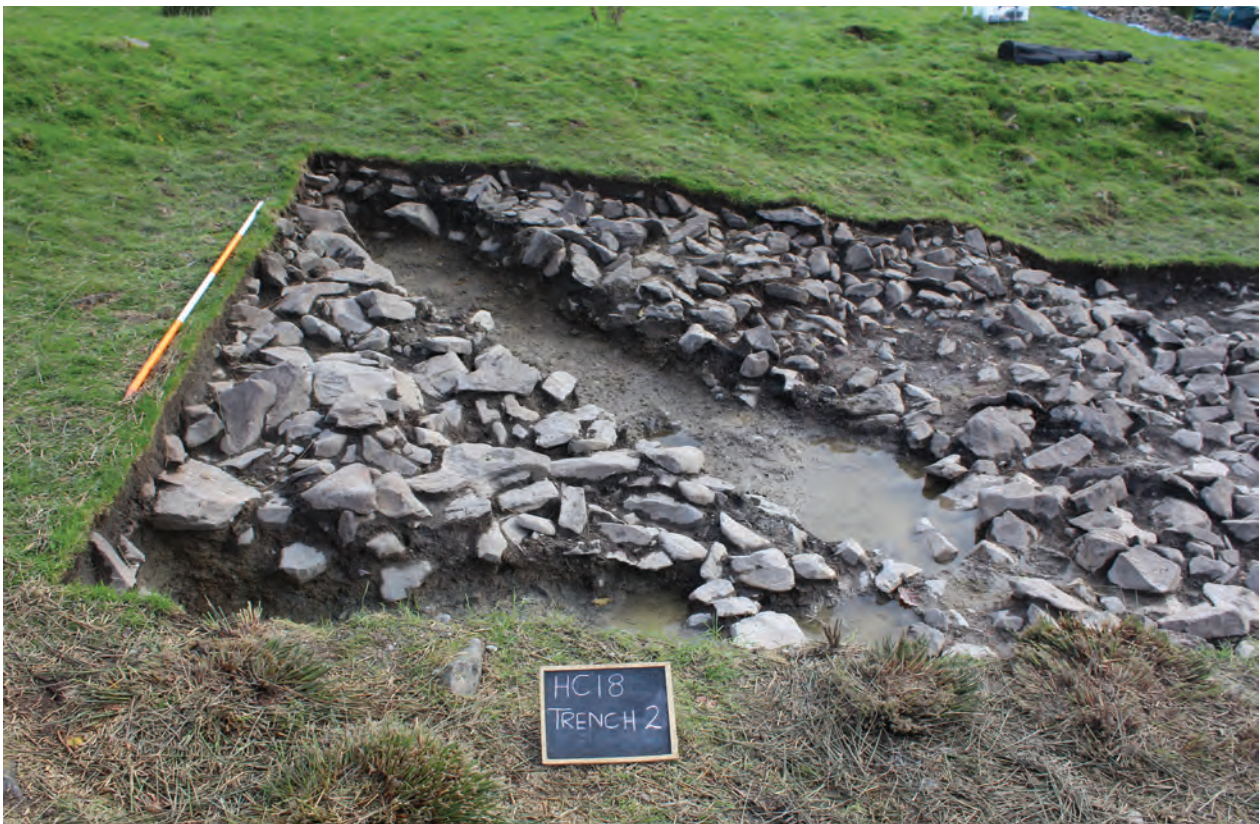
Figure 33 Enclosure bank (2007), facing south-east. Scale 2 m

The earliest feature observed within Trench 2 was a curvilinear banked earthwork running through the south-eastern and south-western extents of the trench, which was visible prior to excavation. The feature was constructed of angular local scree stones (2007) which supported the interior face of the enclosure bank. The stones were generally laid in a single rough layer over the natural slope, which was partially augmented during the bank's construction (see below). The deposit of stone was generally thicker at the top of the bank becoming thinner downslope and the interior of the enclosure bank had a slightly concave profile. The very top of the bank was beyond the limit of excavation, and time constraints meant that it was not investigated at this location (see Trench 3). Colluvium (2001) was not present near the top of the bank, where stones protruded through the topsoil (001), but was observed towards the lower extents.

Immediately beneath the colluvium (2001) (where observed) was an abundance of sub-angular scree stones (2007), measuring an average size of c. 300 x 200 x 100 mm, which were generally laid in a single layer, pitched obliquely against the angle of the bank slope, no discernible facing was observed. These stones, which provided a robust revetment to the interior slope of the enclosure bank, were embedded into a dark reddish-brown silty soil (2018) with coarse sub-angular stone inclusions, which measured approximately 0.1 m in thickness. This soil deposit covered the core make-up of the bank and may represent an earlier phase of the bank prior to being faced with stone. This deposit overlay a compacted, light orangey-beige, clayish sandy redeposited natural substrate (2017) which measured approximately 0.1 m in thickness where it abutted the revetment kerb slabs (2016) (see below), increasing to approximately 0.25 m in thickness at the limit of excavation, and which formed the central core of the enclosure bank. The incline of the bank suggests this deposit would increase in thickness to form the core mound. An alignment of stone kerbing (2016) was laid to contain the redeposited natural substrate (2017). The stone kerb was generally laid as two courses of flat slabs which measured c. 340 x 300 x 60 mm on average. The revetment kerb, which measured approximately 0.40 m wide, followed the natural curve of the hillside at this location. The enclosure bank was constructed directly onto the natural substrate (2014) of the hillside.
