Digging for Britons! High Carlingill, Cumbria

2018 Community Archaeology Excavation Interim Report

| Project Reference: | SOL1718-93 |

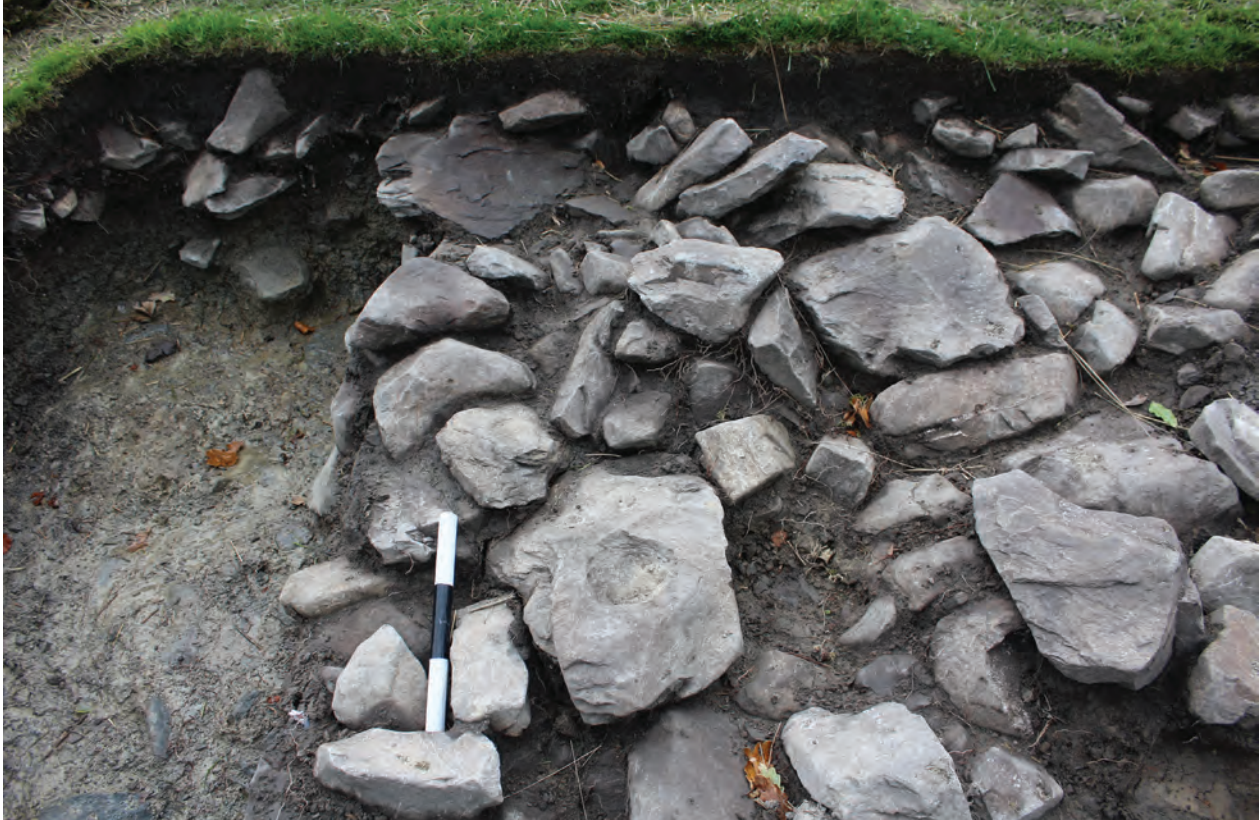
Figure 35 Flat stone with pecked dished depression, facing east. Scale 0.3 m

In among the revetment stones (2007) of the enclosure bank, a stone was observed approximately midway up the slope, which had a flat upper surface into which a dished depression had been pecked. A structural use for the stone could not be determined in relation to its position in relation to the other features in the trench, and therefore it was interpreted as having been reused from elsewhere. No similar stones were observed in Trench 2.

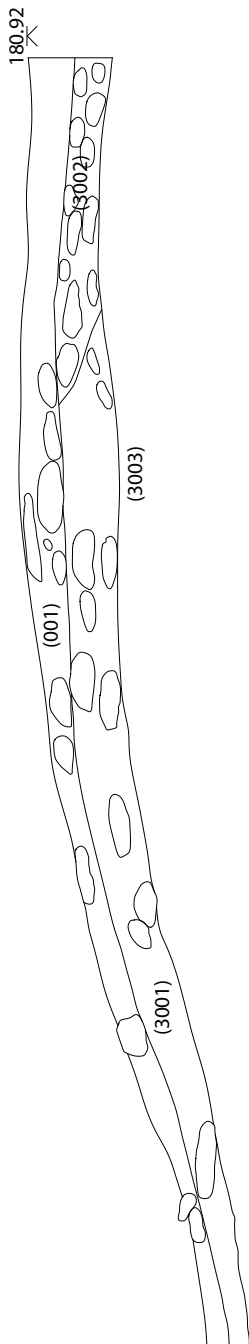
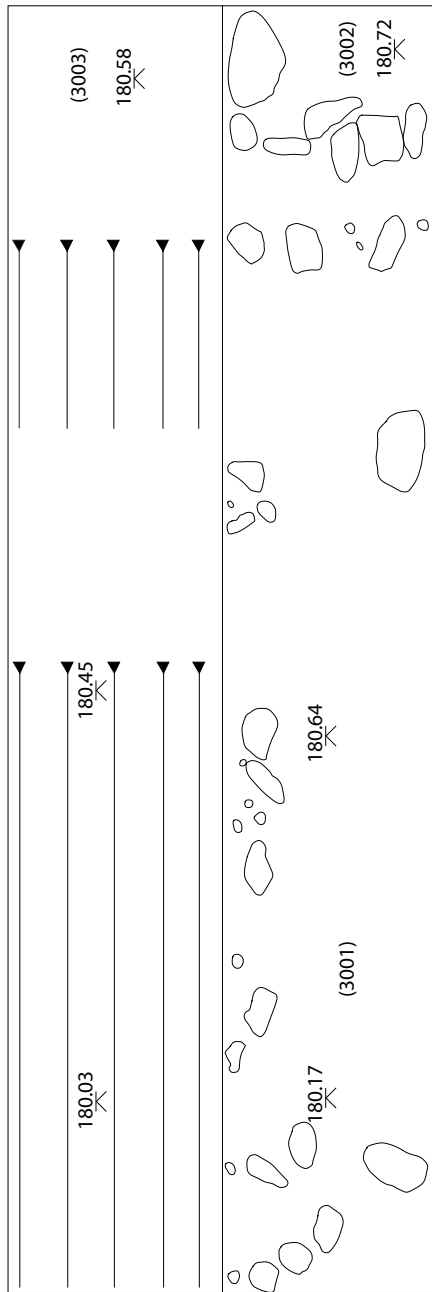
| Drawing | Post-excavation plan of Trench 3 |

Trench 3 was opened approximately 7.5 m along the enclosure bank, to the north of Trench 2. This trench specifically targeted the enclosure bank to characterise and understand its form and construction in an area away from structural intrusion. The trench measured 6 m by 2 m in plan, extended from the top the enclosure bank and was orientated towards the south-west. Immediately beneath the turf and topsoil (001) a level area of stone (3002) was observed at the top of the bank. The stones were a collection of larger flatter stones measuring an average of c. 450 x 200 x 80 mm in size, interspersed with smaller sub-angular stones measuring an average of c. 150 x 200 x 80 mm in size. The stones were randomly distributed but created a flattened upper surface to the bank which extended to the break of slope where they overlay pitched stones (3001). Where (3002) met (3001) the former stones lipped up and slightly over the latter, creating a raised edge along the break of slope of the enclosure bank. It was uncertain whether (3001) / (3004) had been cut to enable the deposition of (3002).

The stone spread forming (3001) appeared as a revetment on the interior of the enclosure bank, probably the same as (2007) observed in Trench 2. The stones were randomly distributed, sub-angular in form, and ranged in size from c. 200 x 120 x 100 mm to c. 400 x 400 x 100 mm. The revetment stones were pressed into a dark grey brown silty soil deposit (3004) with coarse, sub-angular stone inclusions, which measured approximately 0.1 m in thickness and directly overlay a plastic, green-grey redeposited clay substrate (3003) which formed the core of the bank at this location. The trench was not extended far enough downslope to determine if a stone kerb, like (2016) (see Trench 2), was present.

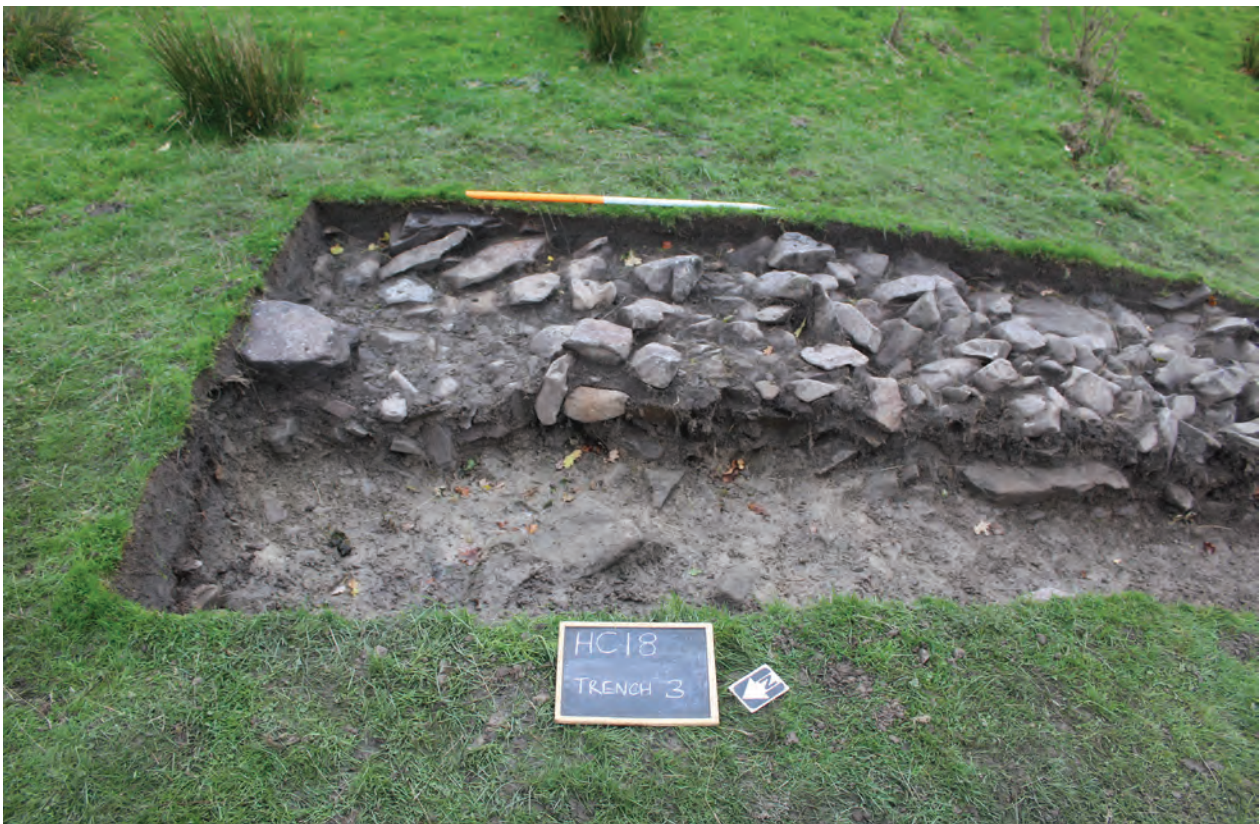
Figure 38 (3002) (left of image) can be seen overlaying (3001) (right of image), facing south-east. Scale 1 m

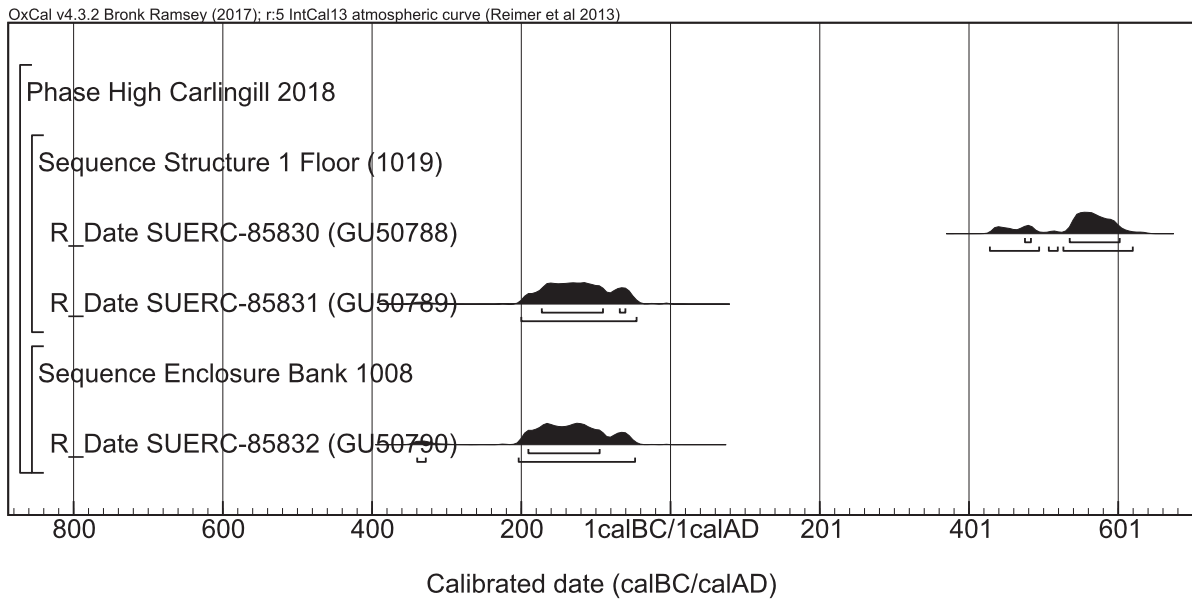
Figure 39 Probability distributions of dates from the 2018 excavations at High Carlingill. Each distribution plot represents the relative probability that an event happened at a certain time

The samples submitted for radiocarbon determination comprised a pair of duplicate dates from the floor surface (1019) of a possible roundhouse (Structure 1), and a single sample from the stone bank (1008) of a sub-rectilinear enclosure feature. The two dates for the possible roundhouse floor surface were obtained on samples of a charred hazelnut shell and birch charcoal and returned very different results. The most likely date range for the charred hazelnut shell was cal AD 430–620 (95.4% probability), whilst the birch charcoal returned a date of between 200–50 cal BC (95.4% probability). The date from the stone bank of the sub-rectilinear enclosure sample was obtained from willow/poplar charcoal and returned date range of 340–50 cal BC (95.4% probability). No stratigraphic relationships existed between the two dated contexts. The two determinations which have returned a range within the Iron Age appear at first glance to have a slightly different span, but the 1^σ (68.2% probability) spans for each are close to identical – 170-60 cal BC and 190-100 cal BC respectively. Given that these are from two deposits which are stratigraphically unrelated, these dates are a strong indication of activity and settlement at the site in the later Iron Age. The unusual date within the sequence is that obtained from charred hazelnut shell within the Structure 1 floor surface. The determination of cal AD 430-620 (95.4% probability) places this sample within the post-Roman and pre-Anglo-Saxon period. Whilst presumably representing intrusive material into an earlier deposit, the presence of something so indicative of human activity as a charred hazelnut shell is an indicator of the potential for long-term or multi-period activity at the site.

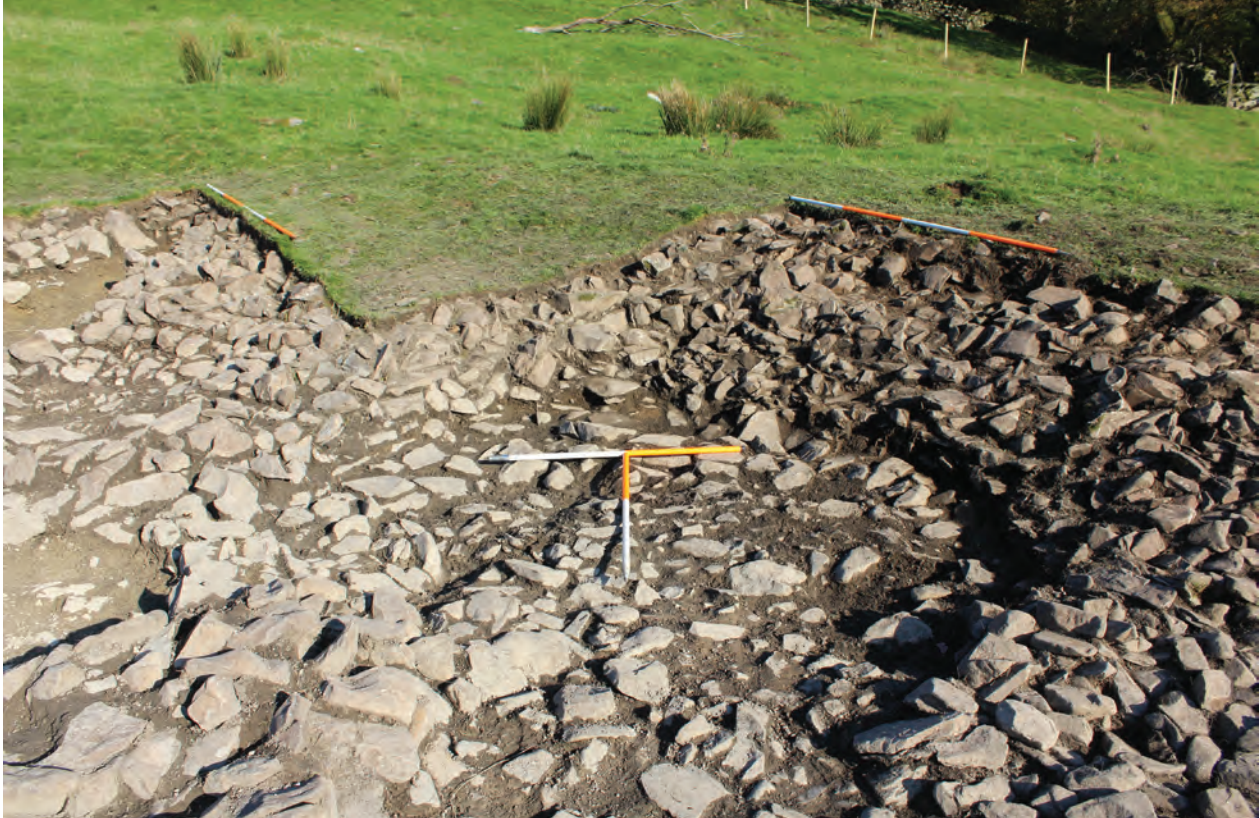
Figure 40 Structure 3 cut back into the Phase 1 enclosure wall behind

Structures 3 and 4 were located on the level platform of a terrace which had been built up against the natural slope of the hillside. The terrace appeared to have been constructed by depositing a compact clay, forming the core of the platform which overlaid the lower extents of the large enclosure bank, to create a level surface against the slope of the hillside — probably to enable the installation of Structures 3 and 4. Revetment stones were observed at the front of, and partially overlaying, the terrace. These roughly laid stones were interpreted as

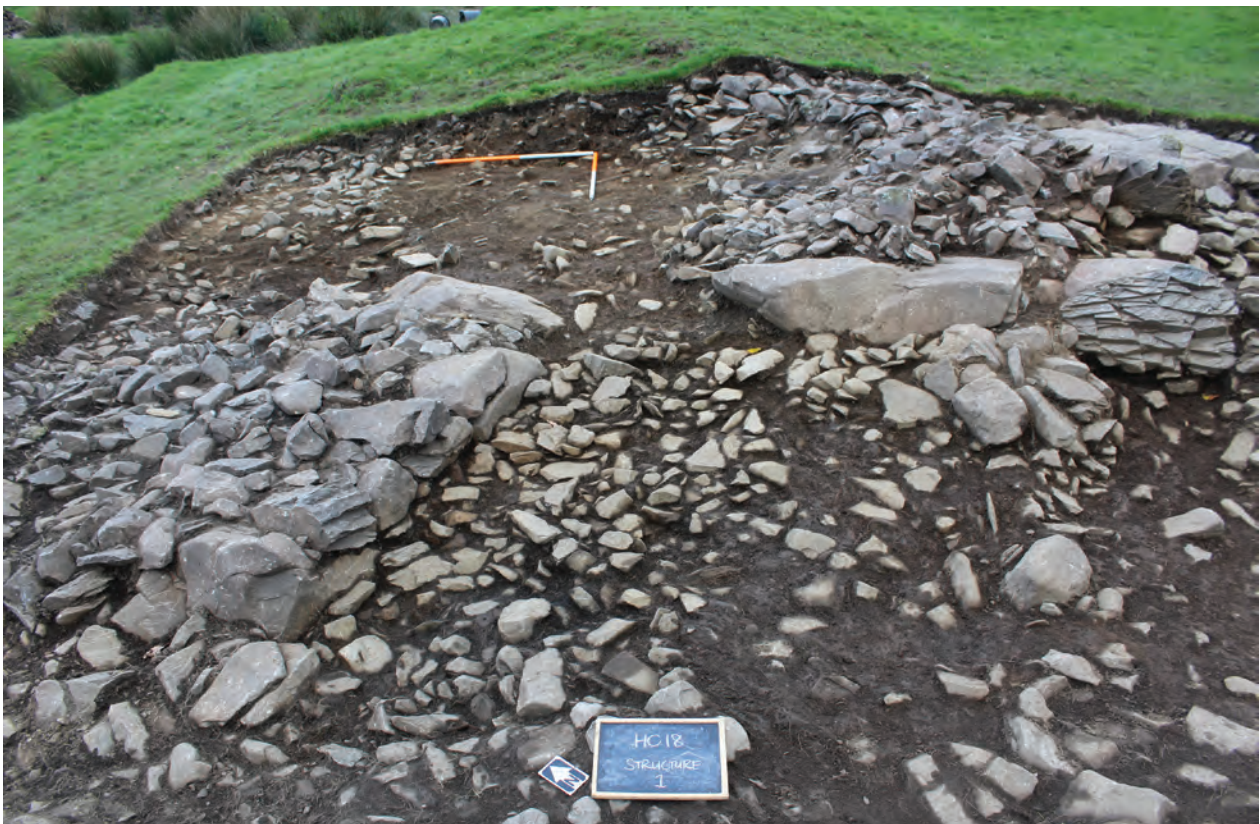
Figure 41 Structure 1 set over the line of the earlier Phase 1 enclosure bank. The original facing stones of the Phase 1 bank can be seen in the front left of shot, and the large foundation stones of the Phase 2 are to the centre-right

A platform of very large flat boulder stones had been constructed to support the southern arc of the structure's wall, aligned to form a corner and roughly faced by using and augmenting natural fractures in the rock. This corner foundation supported the south-eastern arc of the wall of Structure 1 and was set next to a very large, sub-cubic stone carved with two parallel channels, aligned north-east to south-west. The purpose of these

channels remains uncertain though a possible interpretation is that they had been used to direct water run-off from the roof of Structure 1. This was partially supported by the observation of a well-silted gully within the Phase 2 enclosure bank, extending downslope from the stone. It is possible that the formation of the gully was simply a result of water run-off from the channel, rather than being a purposeful construction relating to it, and it was noted that the channel in the rock was not sufficiently deep to effectively contain and direct water. Further consideration of this feature is required.
